Manhole Inspection Summary

Manhole # S49II_005MH

Insp Date: **5/14/08 1:31 PM**

Location Address: **Federal st**

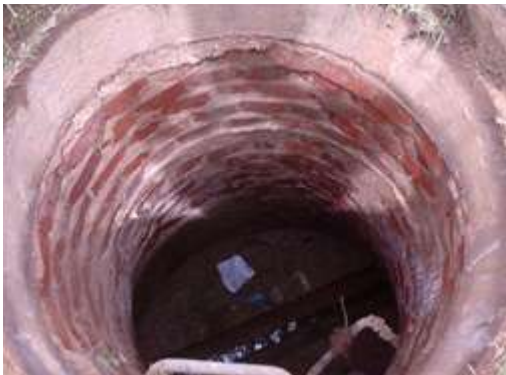
Defect 2

frame leaks

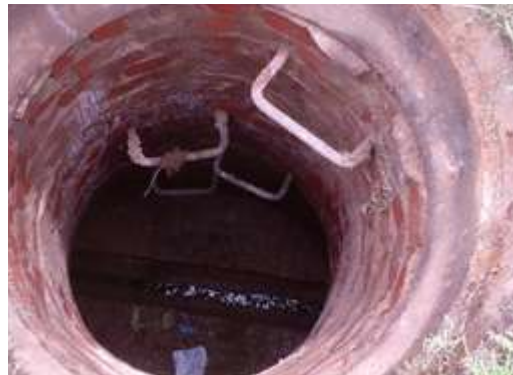
Defect 1

Infiltration: ☐ None ☐ Joint ☐ Cracks ☐ Mortar ☐ Roots ☒ **Wall**

Infiltration

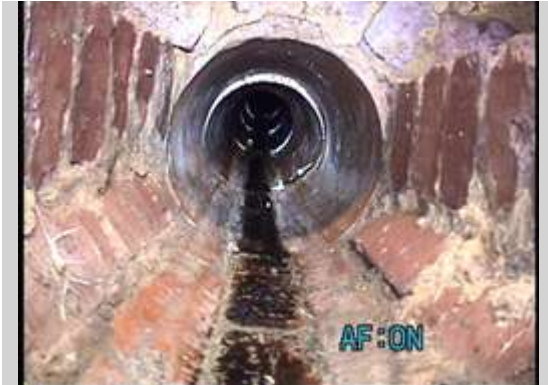
12 O'Clock Outflow

8 in. Circular Gravity Sewer
Pipe Out @ 12 O'Clock

Pipe Height: **8.4** (in.) Rod and Bar (Angled)
Pipe Material: **Clay** ☐ Pipe Lined
Invert Depth: **8.20** (ft.) Flow Characteristics: **Slow**
Deposits: ☒ None ☐ Mud ☐ Sludge ☐ Debris ☐ Grease
Silt Depth: (in.) Deposits Extent:
Infiltration: **None** Pipe Seal Cond: **Sound**

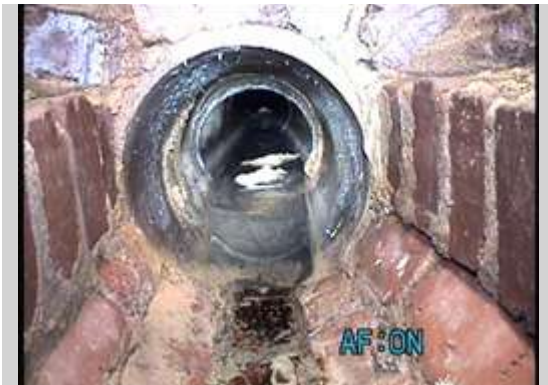
6 O'Clock Inflow

8 in. Circular Gravity Sewer
Pipe In @ 6 O'Clock

Pipe Height: **8.4** (in.) Rod and Bar (Angled)
Pipe Material: **Clay** ☐ Pipe Lined
Invert Depth: **7.95** (ft.) Flow Characteristics: **Slow**
Deposits: ☒ None ☐ Mud ☐ Sludge ☐ Debris ☐ Grease
Silt Depth: (in.) Deposits Extent:
Infiltration: **None** Pipe Seal Cond: **Sound**
